TECHNICAL INSPECTION REPORT

6 OPERATION CROSSROADS.
U.S.S. CRITTENDEN (APA 77)

TEST ABLE.

VOLUME 2 [U].

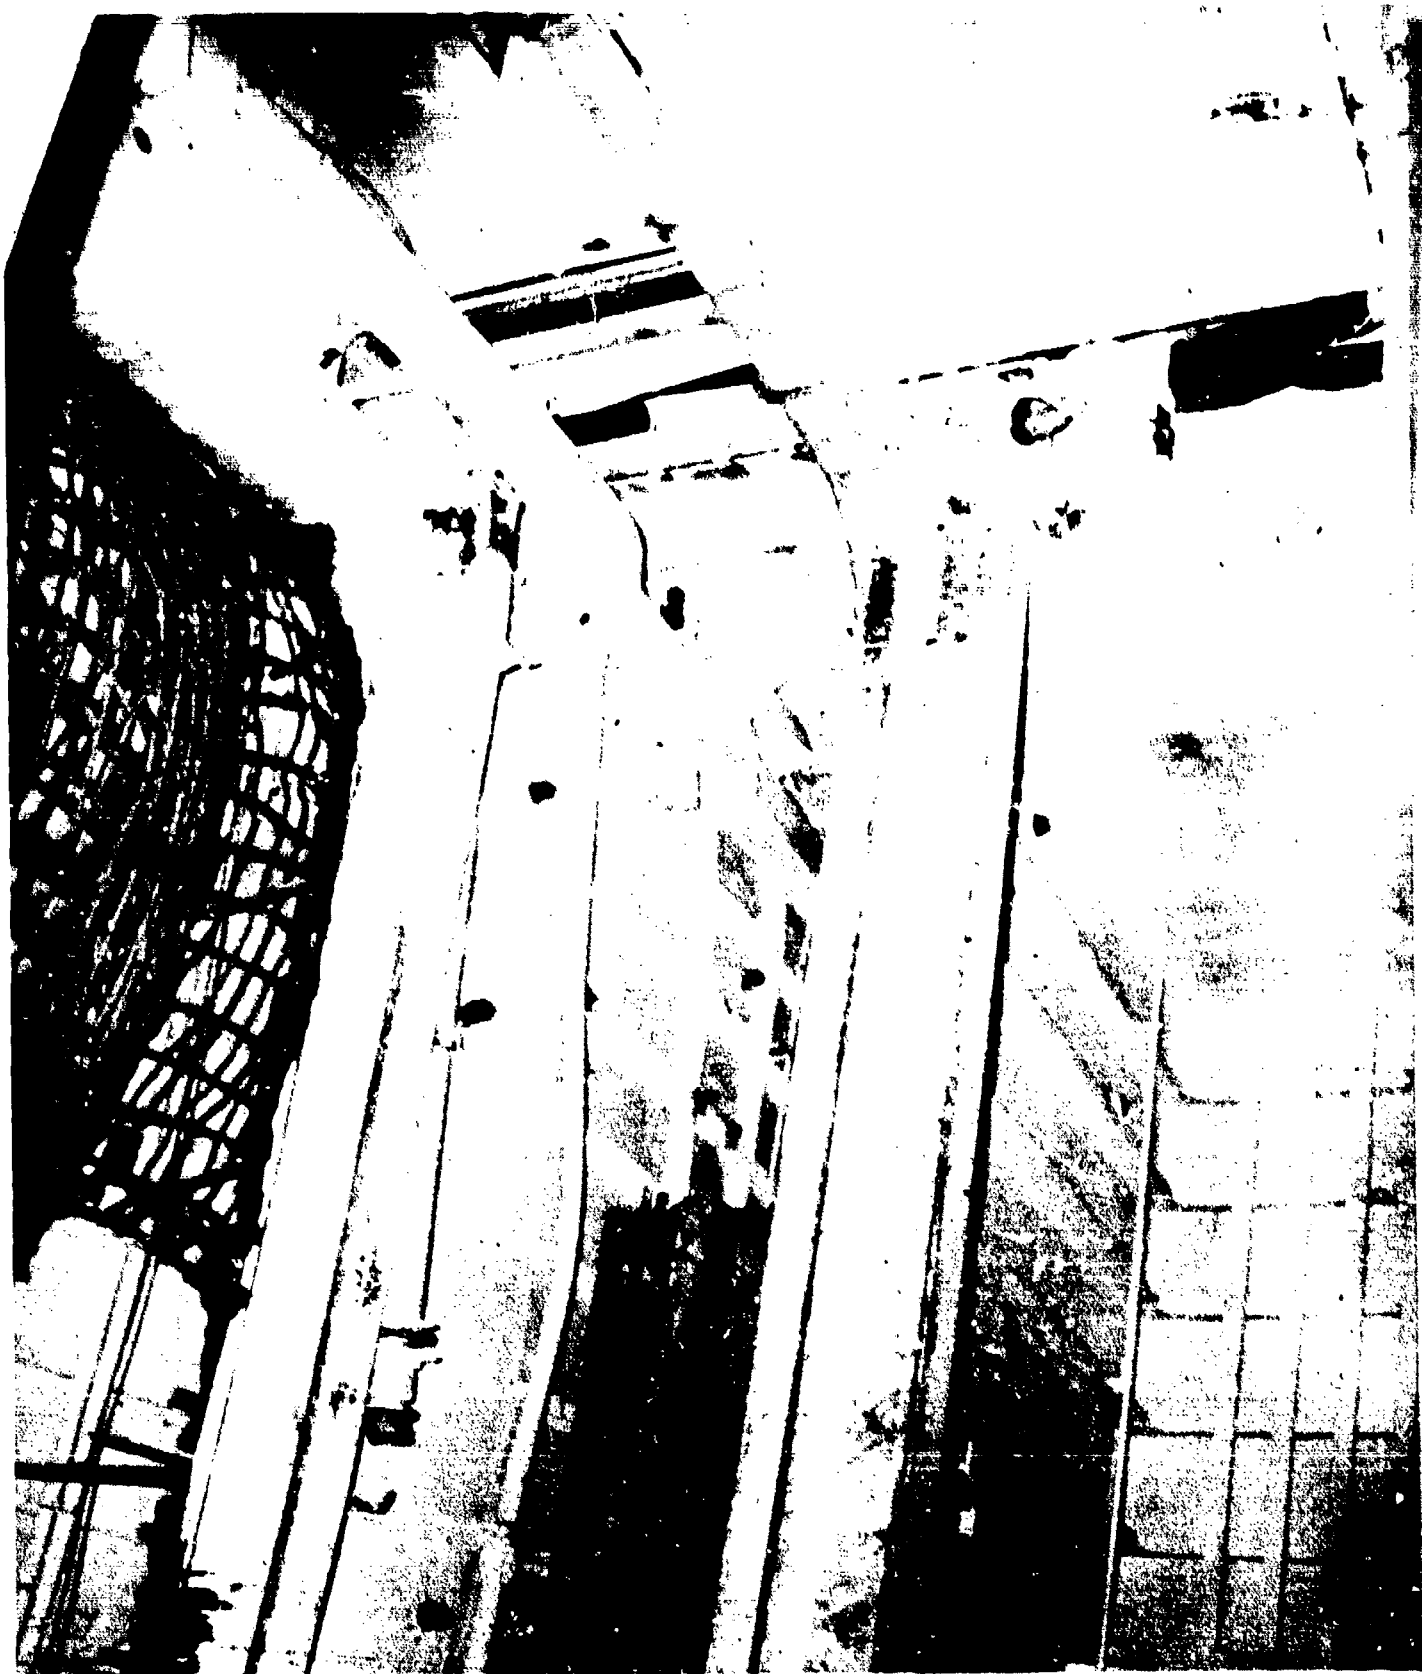
AA-CR-100-1891-2. Looking aft and to starboard in forward cargo hold showing damage to girders in way of starboard edge of hatch at main deck and first platform levels.

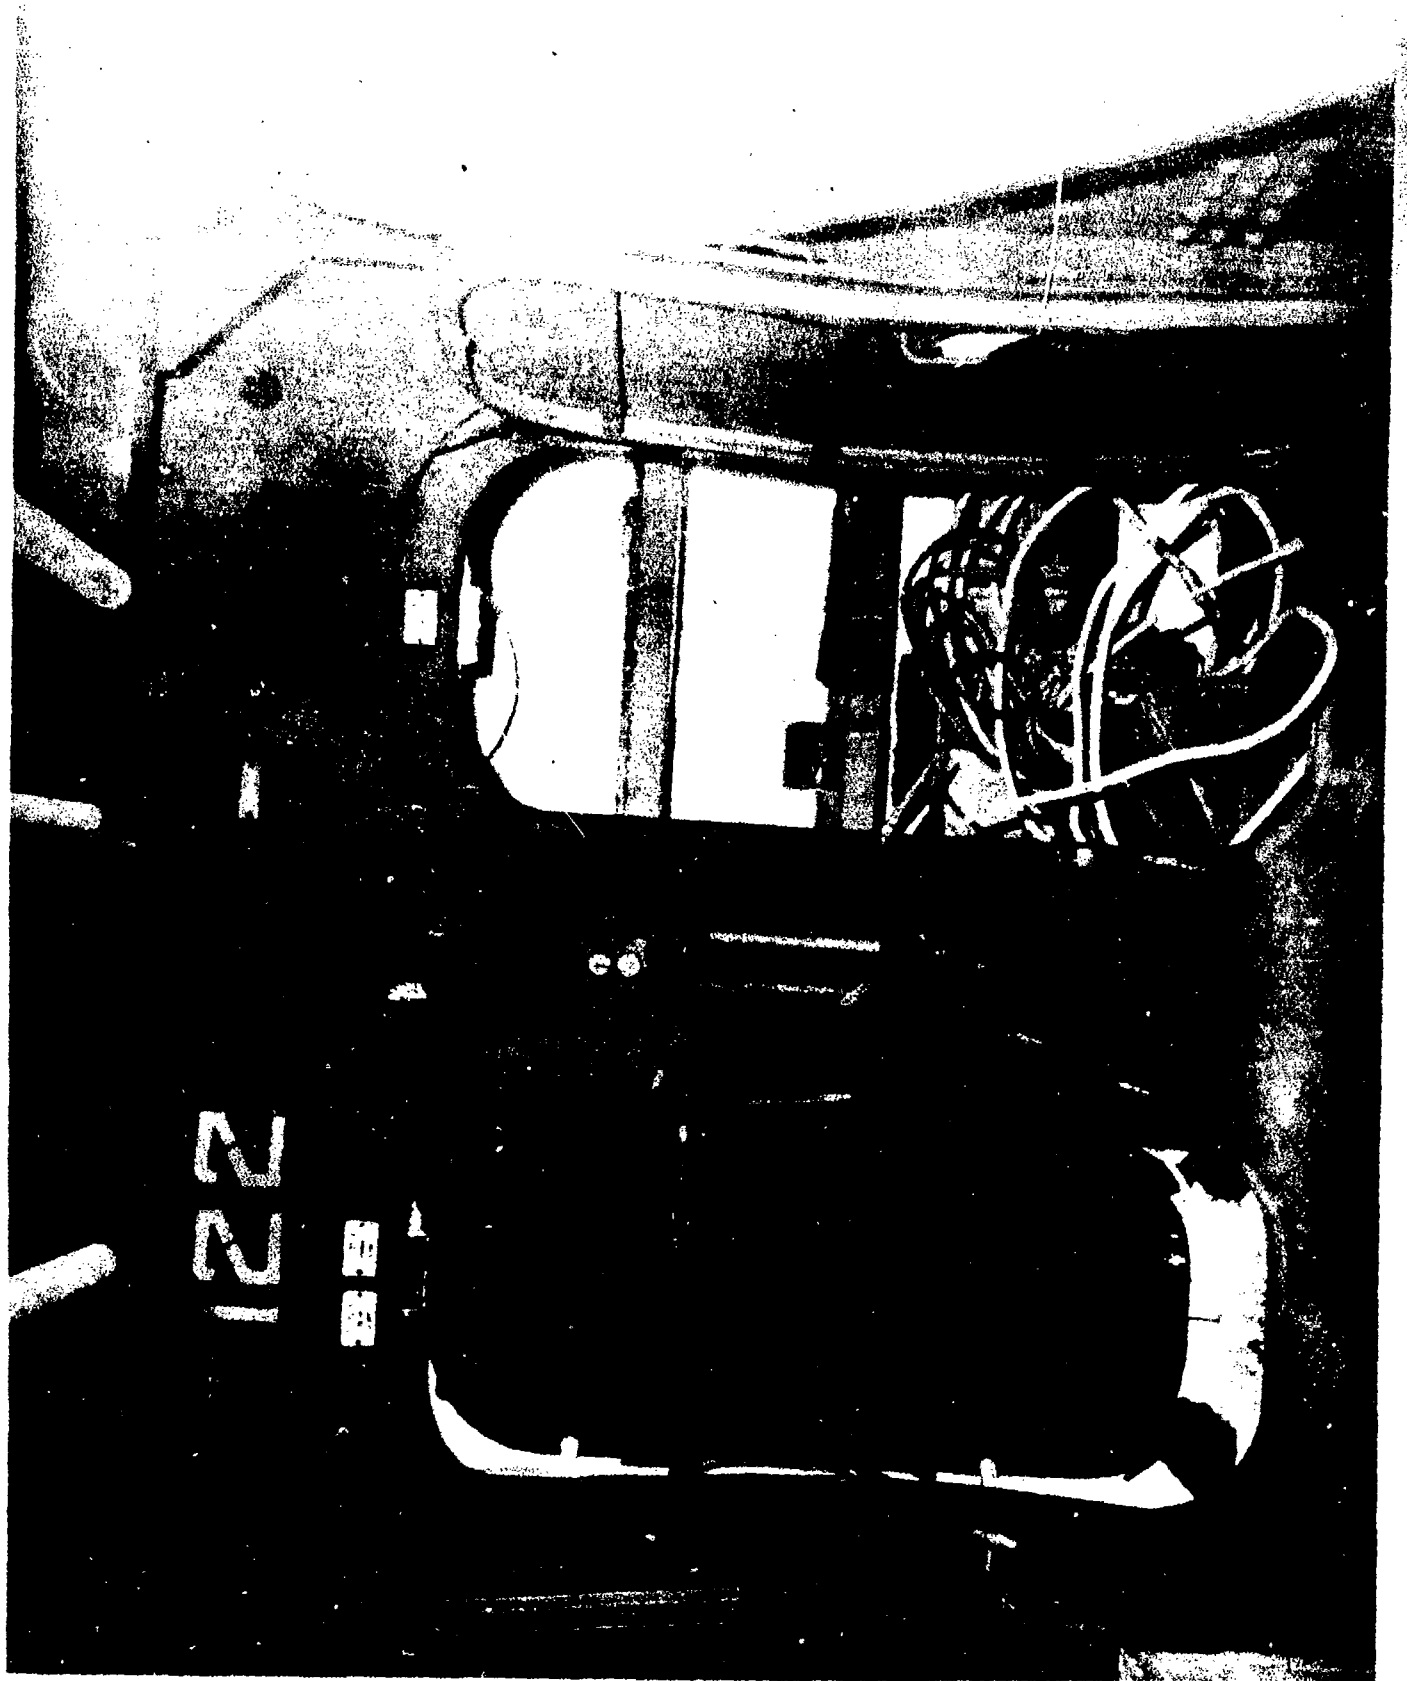
AA-CR-65-1819-1. Looking aft in main deck passageway, port, showing damage to doors in after bulkhead 122.

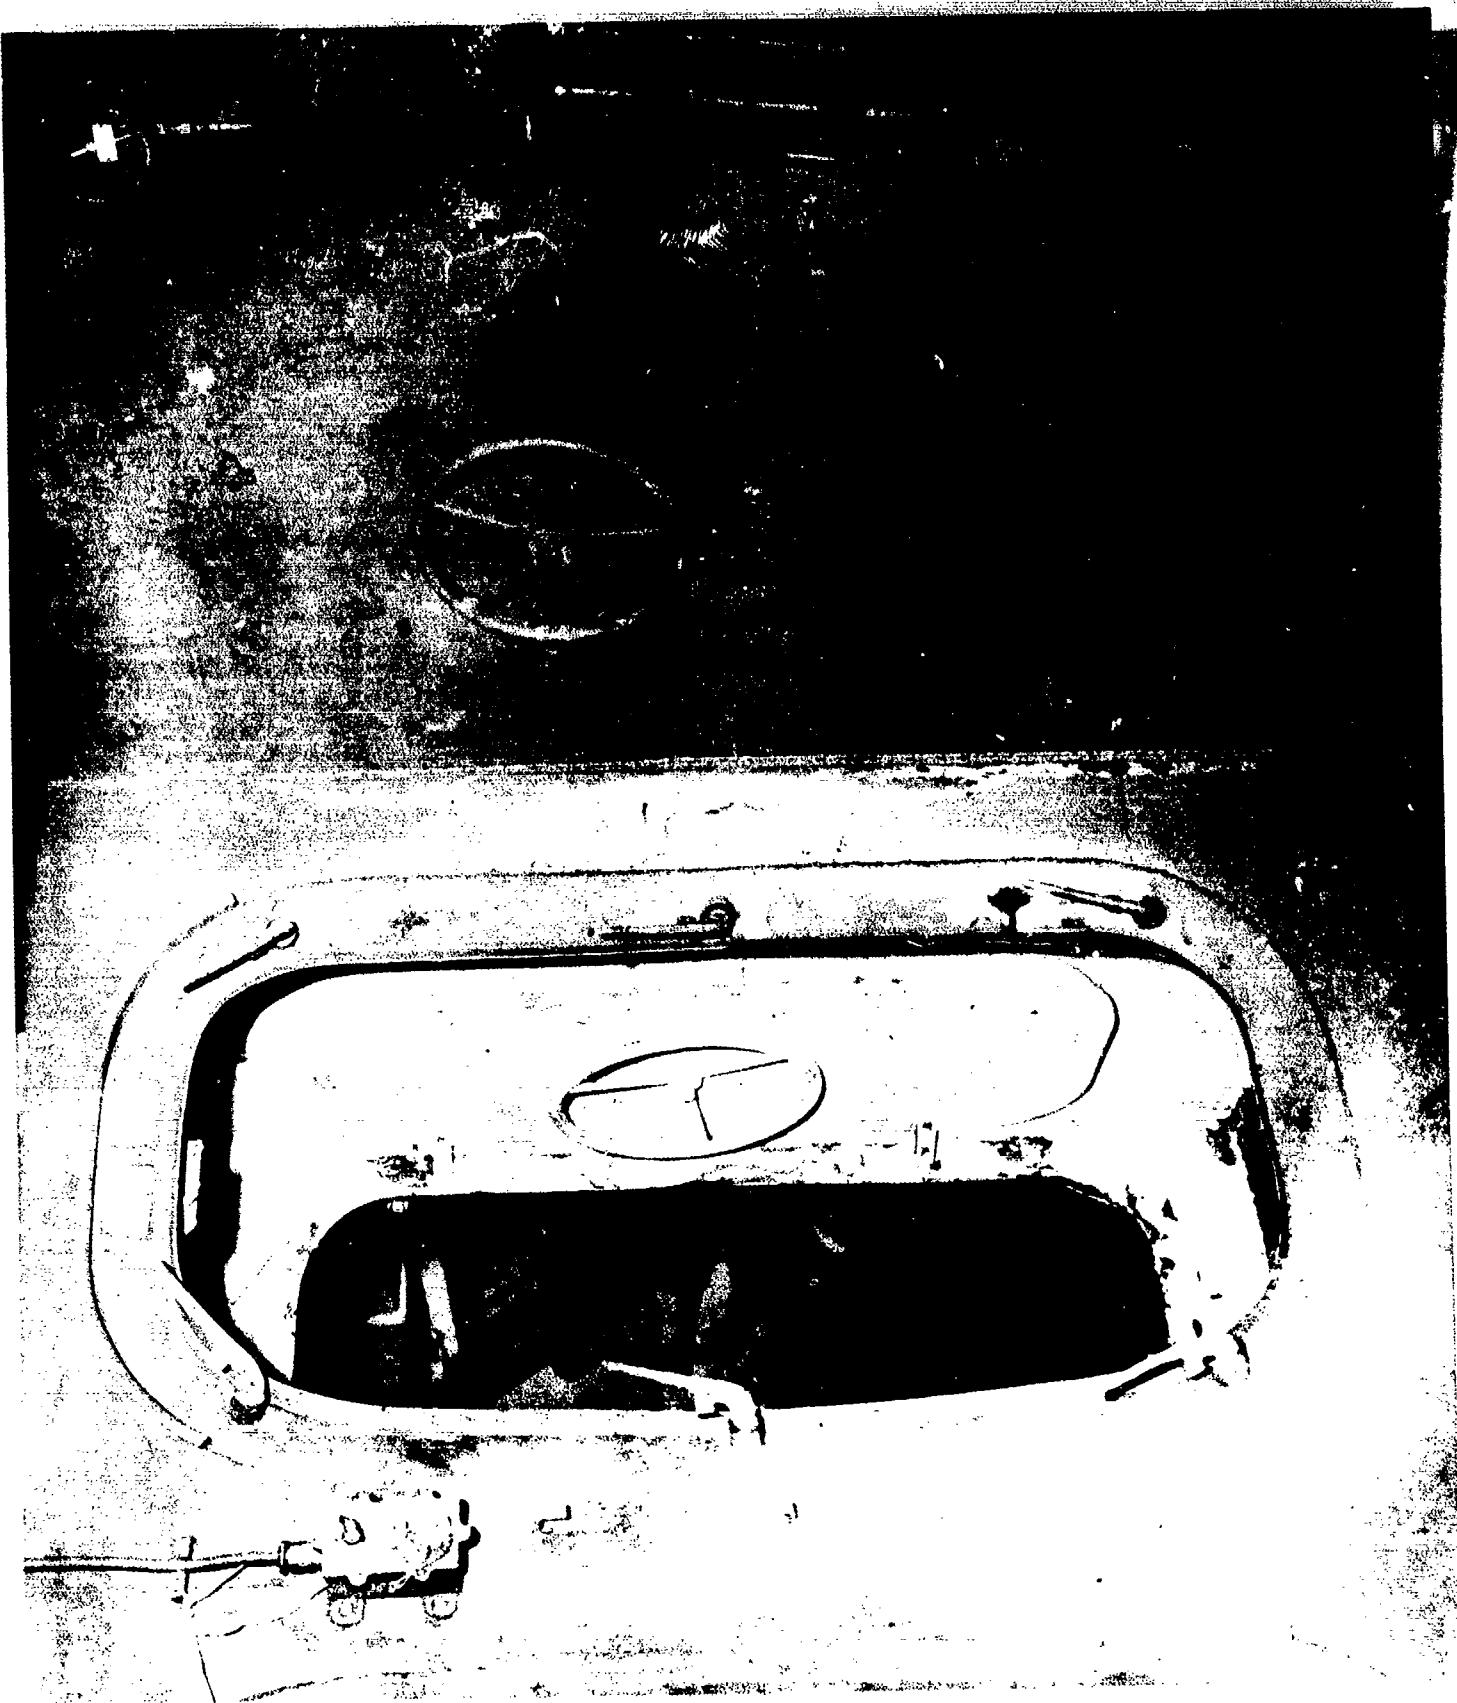
AA-CR-80-1908-8. Looking aft in main deck well, starboard, showing damage to after bulkhead.

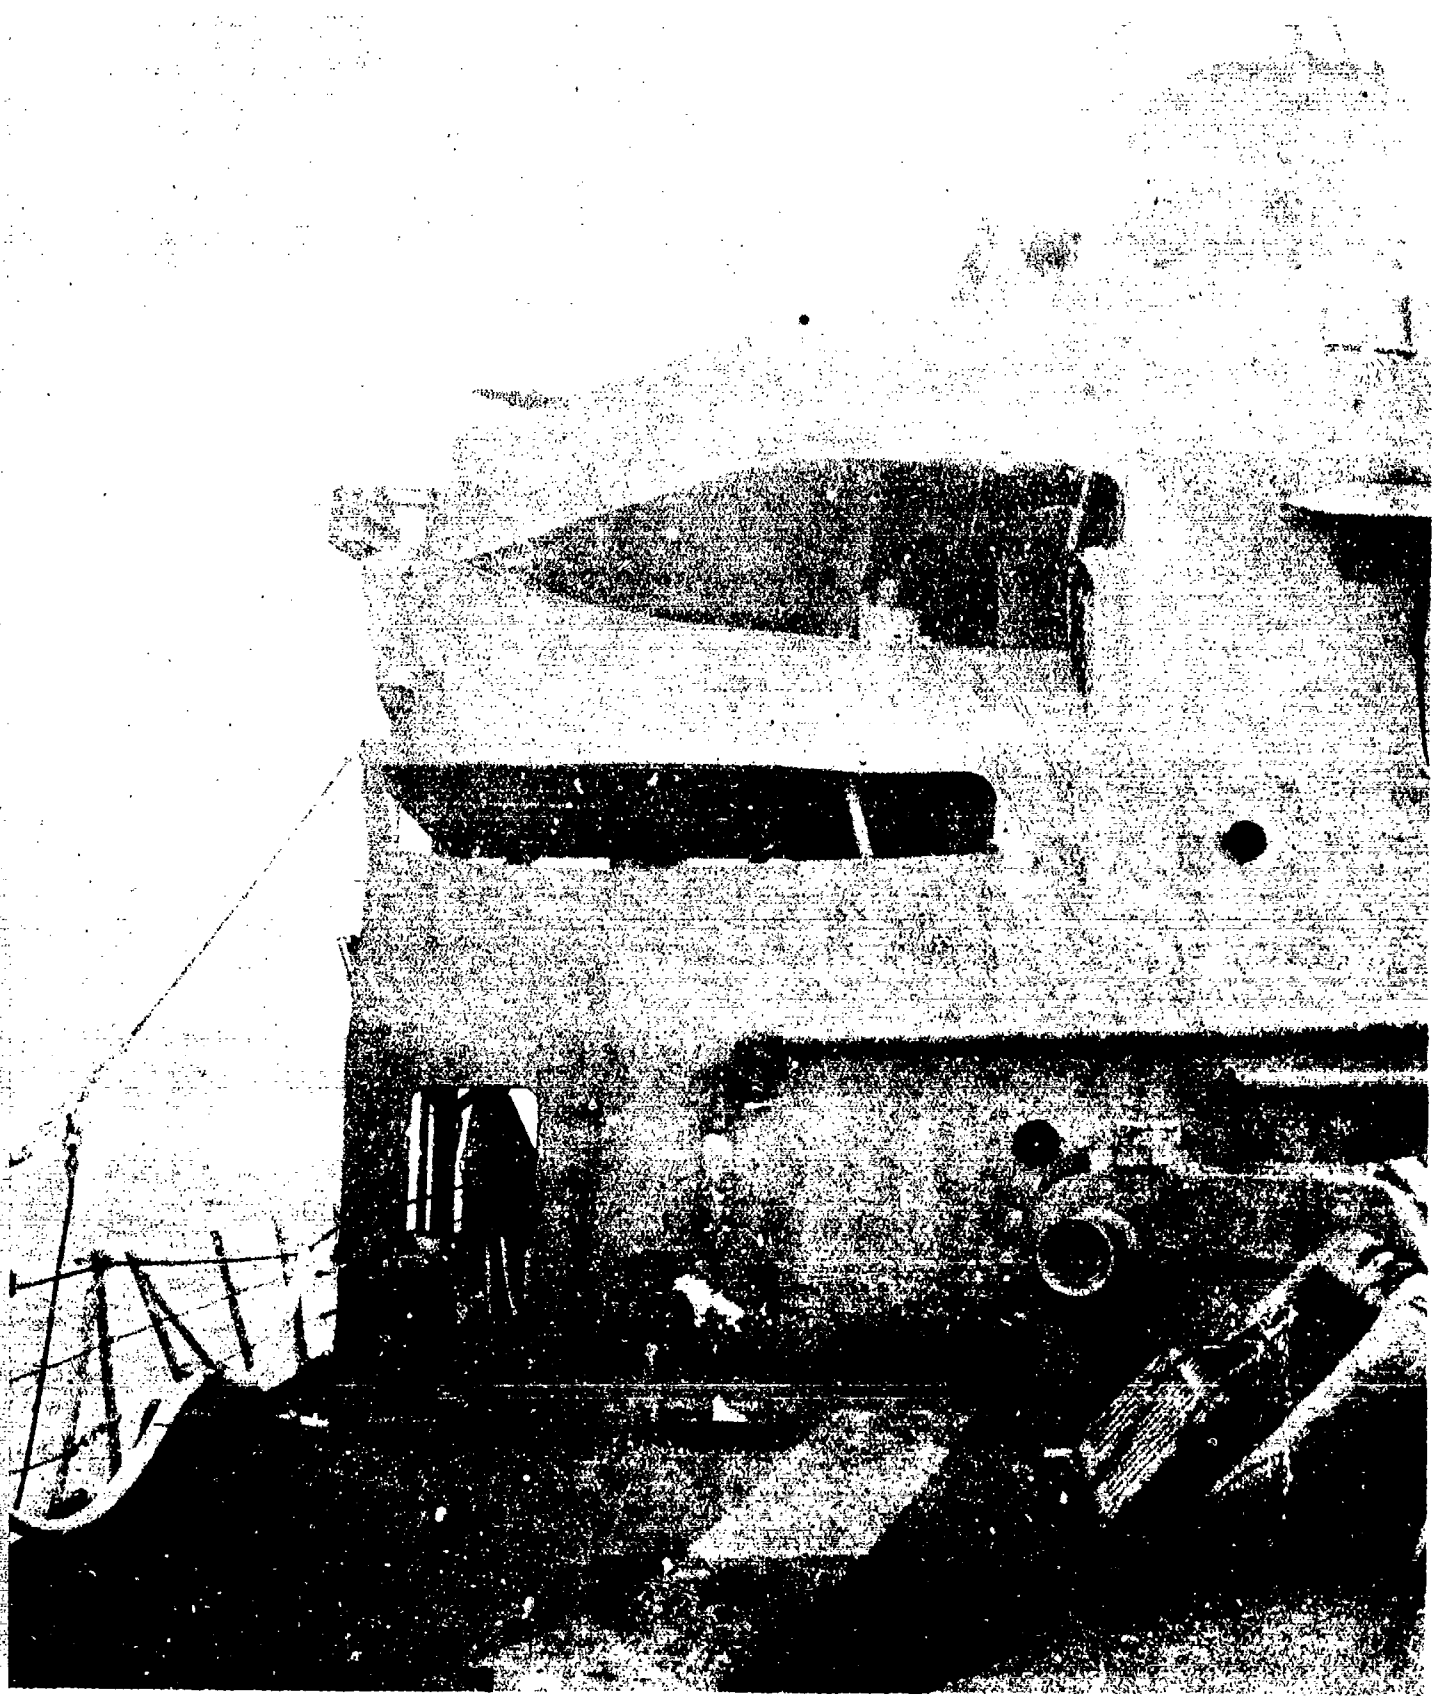
AA-CR-80-1903-3. Looking aft on upper deck showing damage to starboard portion of bridge structure and dishing of deck.

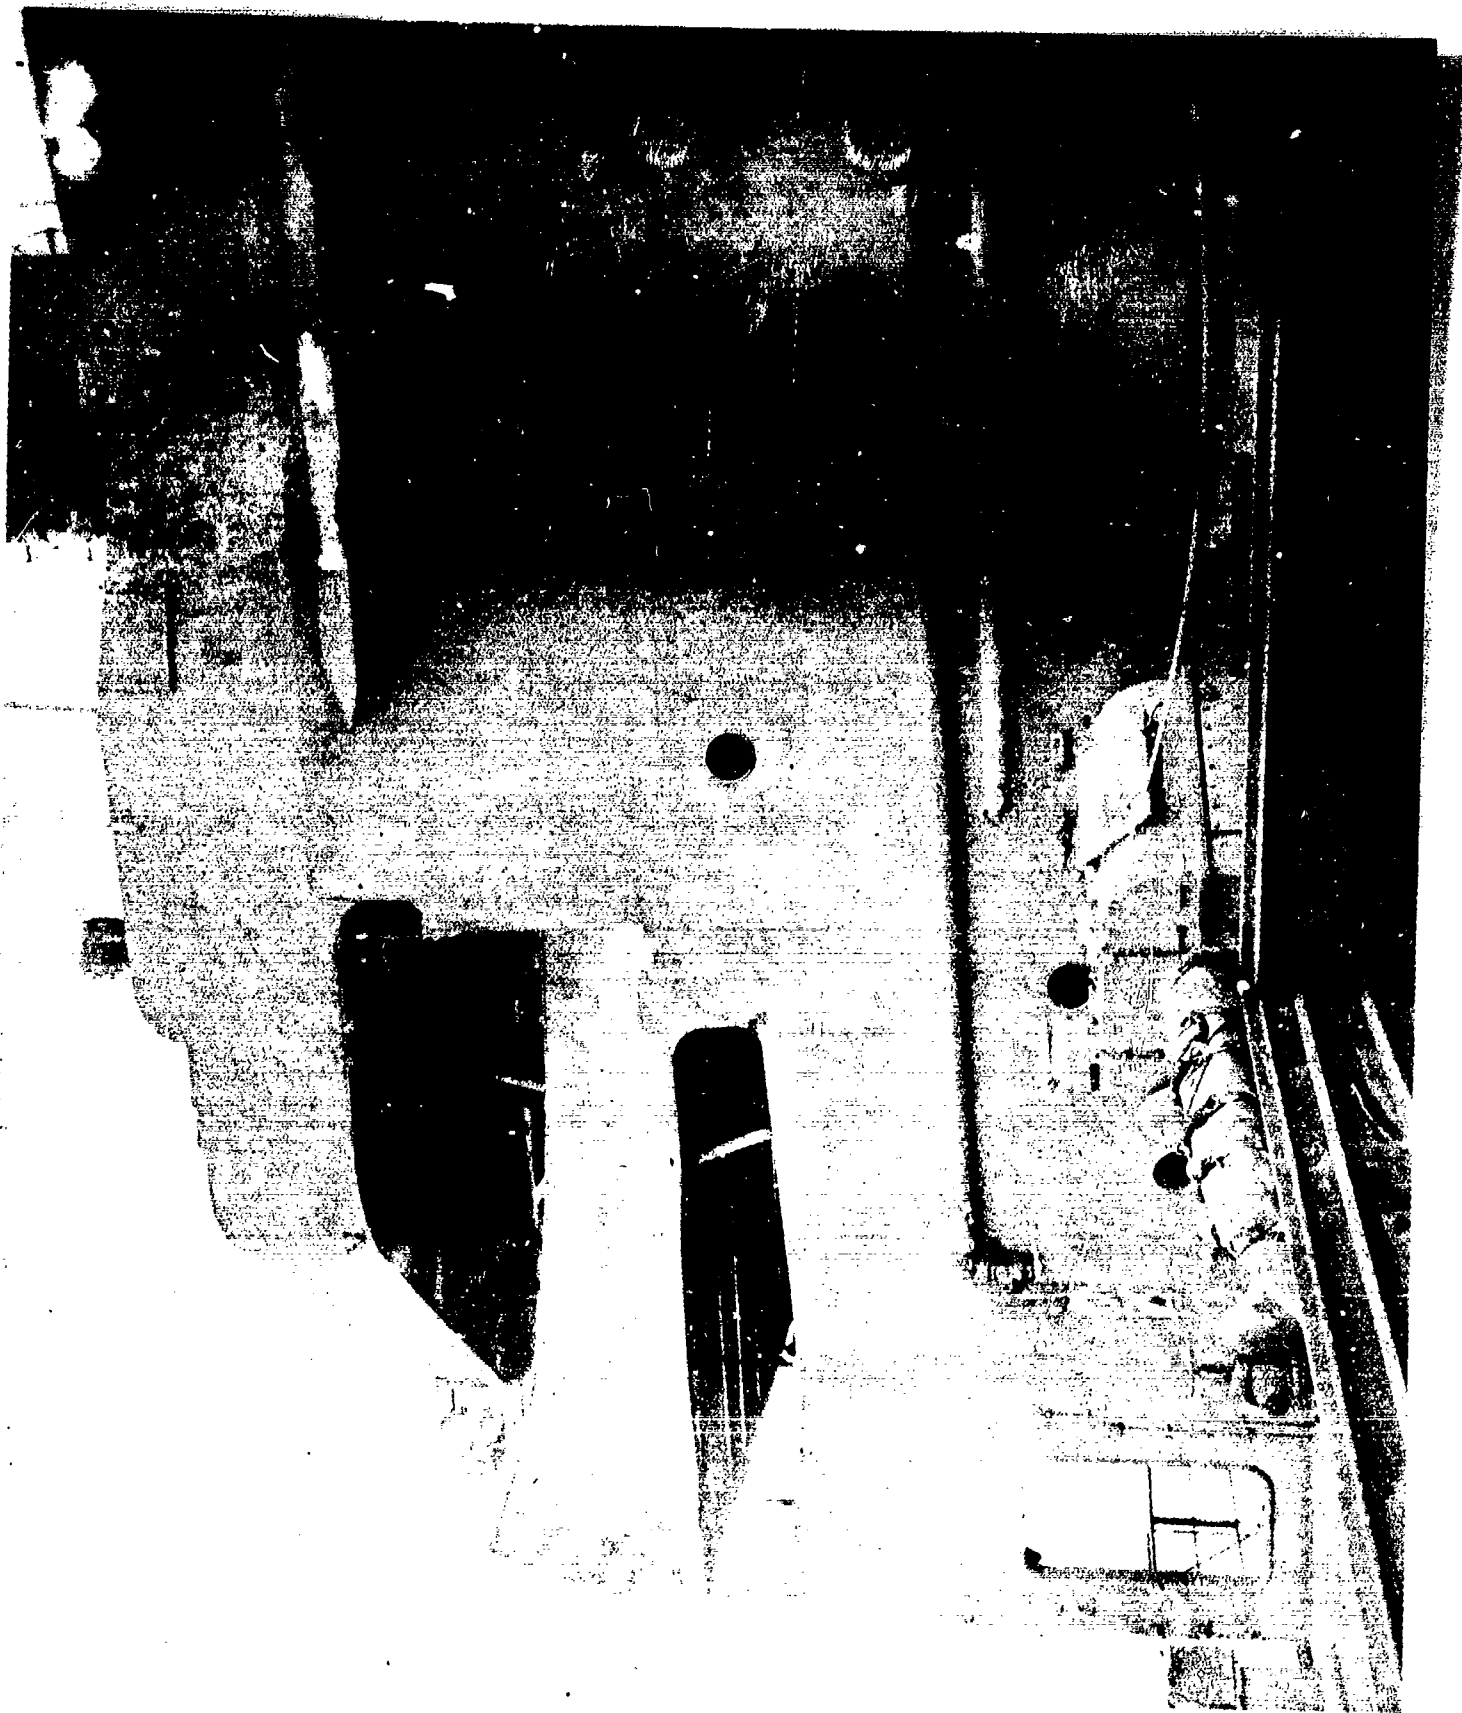
AA-CR-80-1903-4. Looking aft and to starboard on upper deck showing damage to starboard portion of bridge structure.

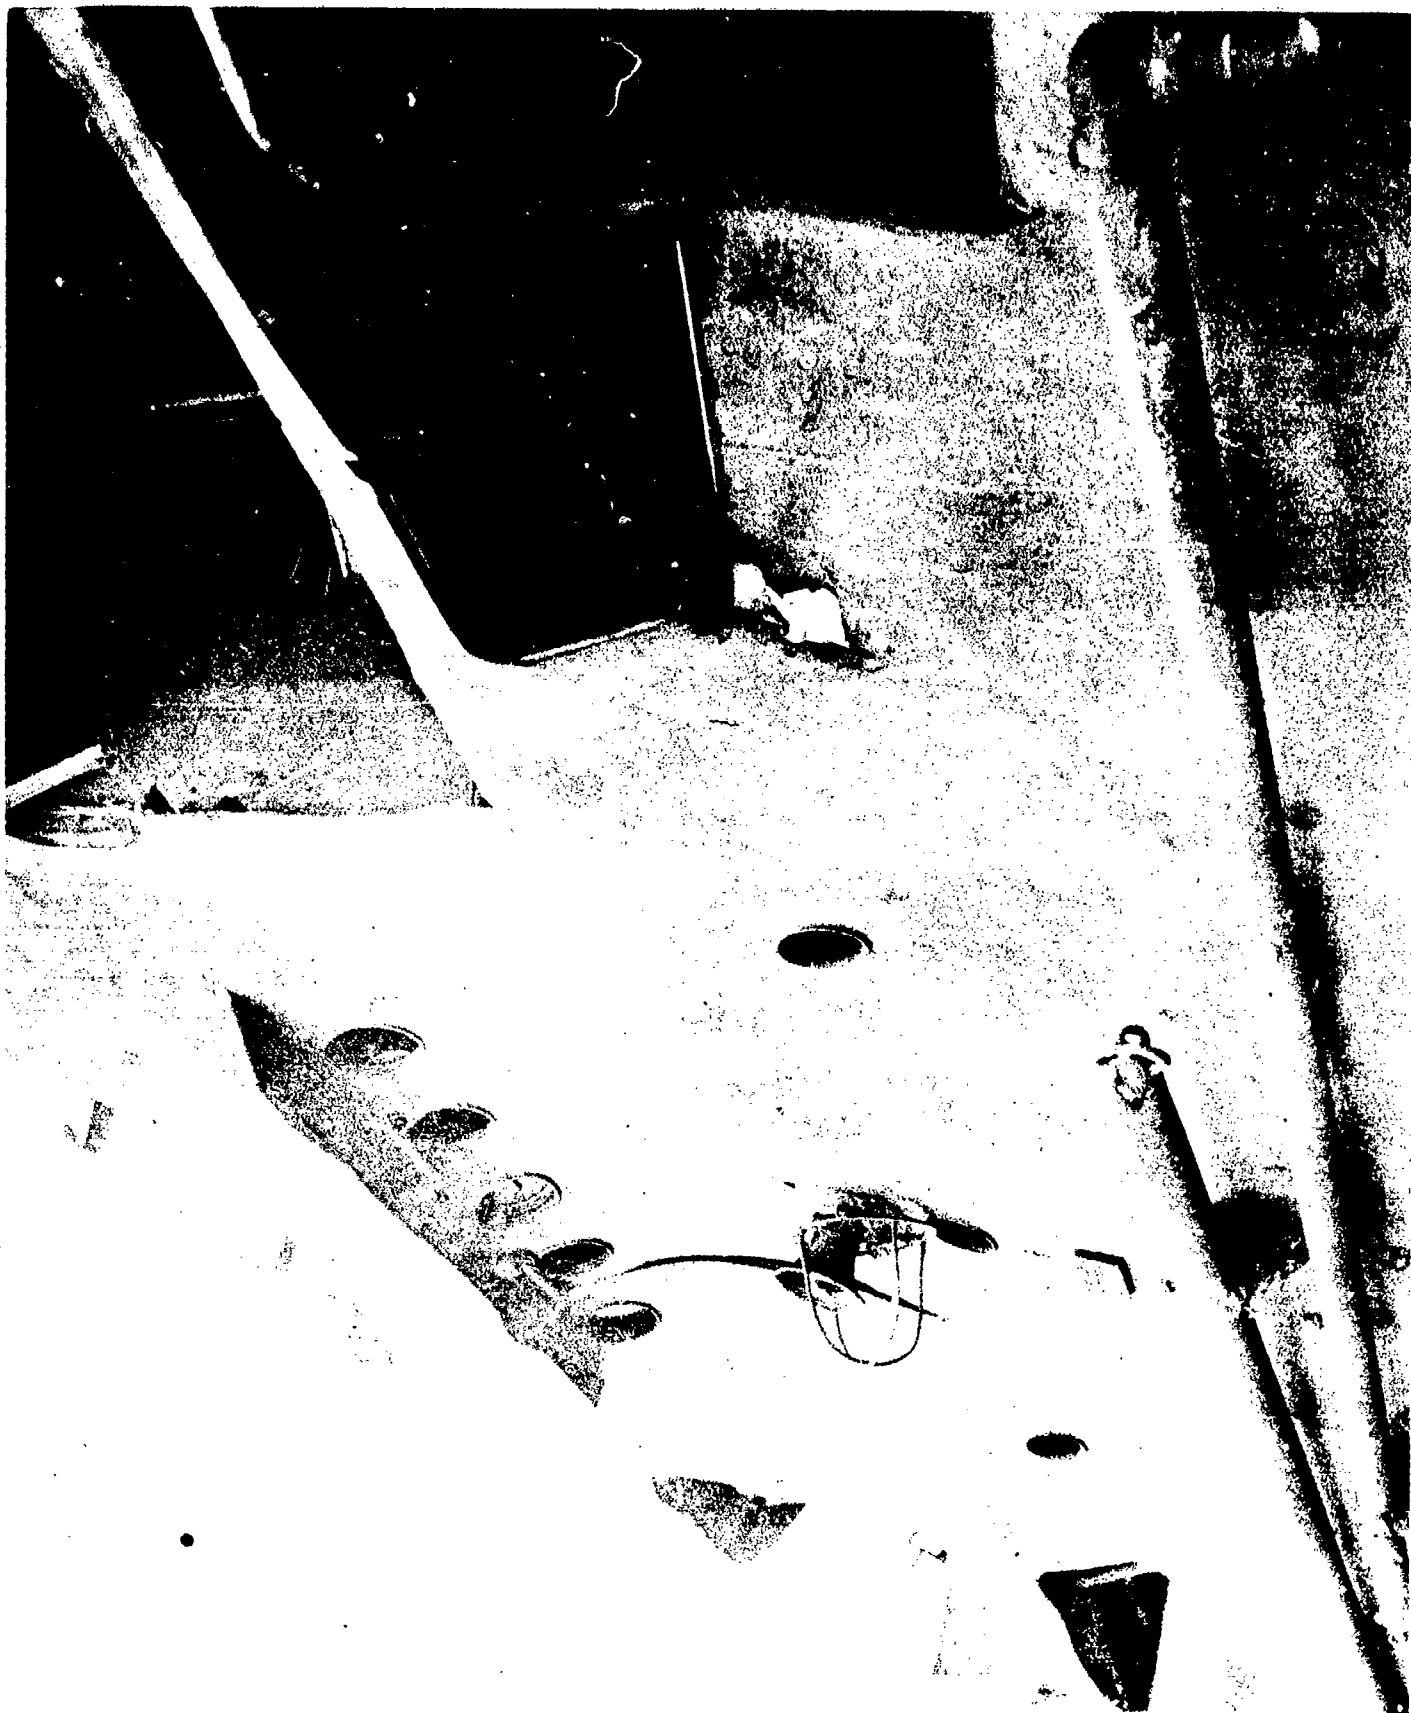
AA-CR-80-1903-8. Looking up, aft, and to starboard from upper deck showing close-up of damage to forward face of bridge structure.

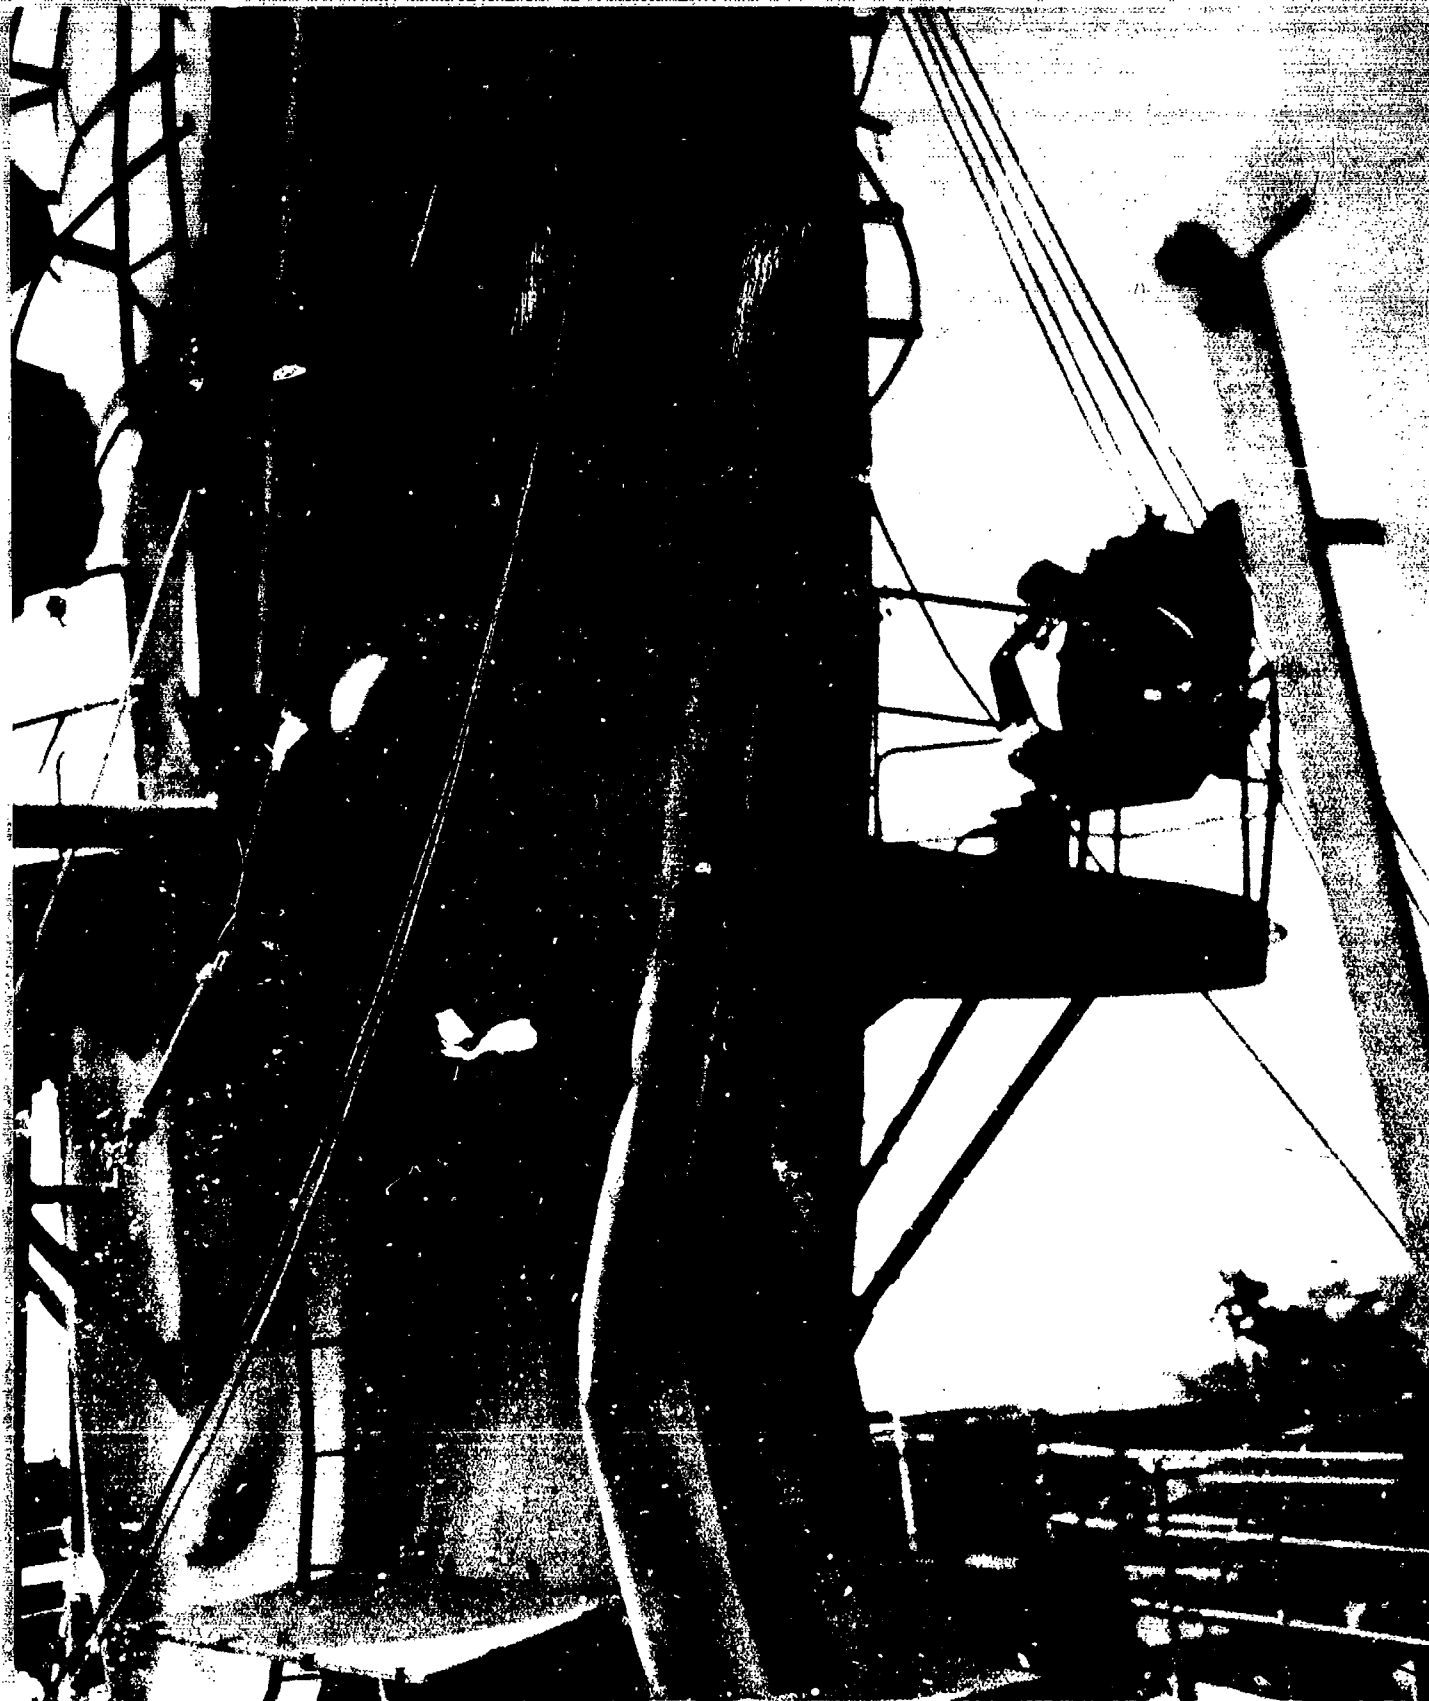
AA-CR-59-2058-10. Looking forward and to starboard on signal bridge level showing damage to after side of forward stack and starboard 24-inch searchlight.

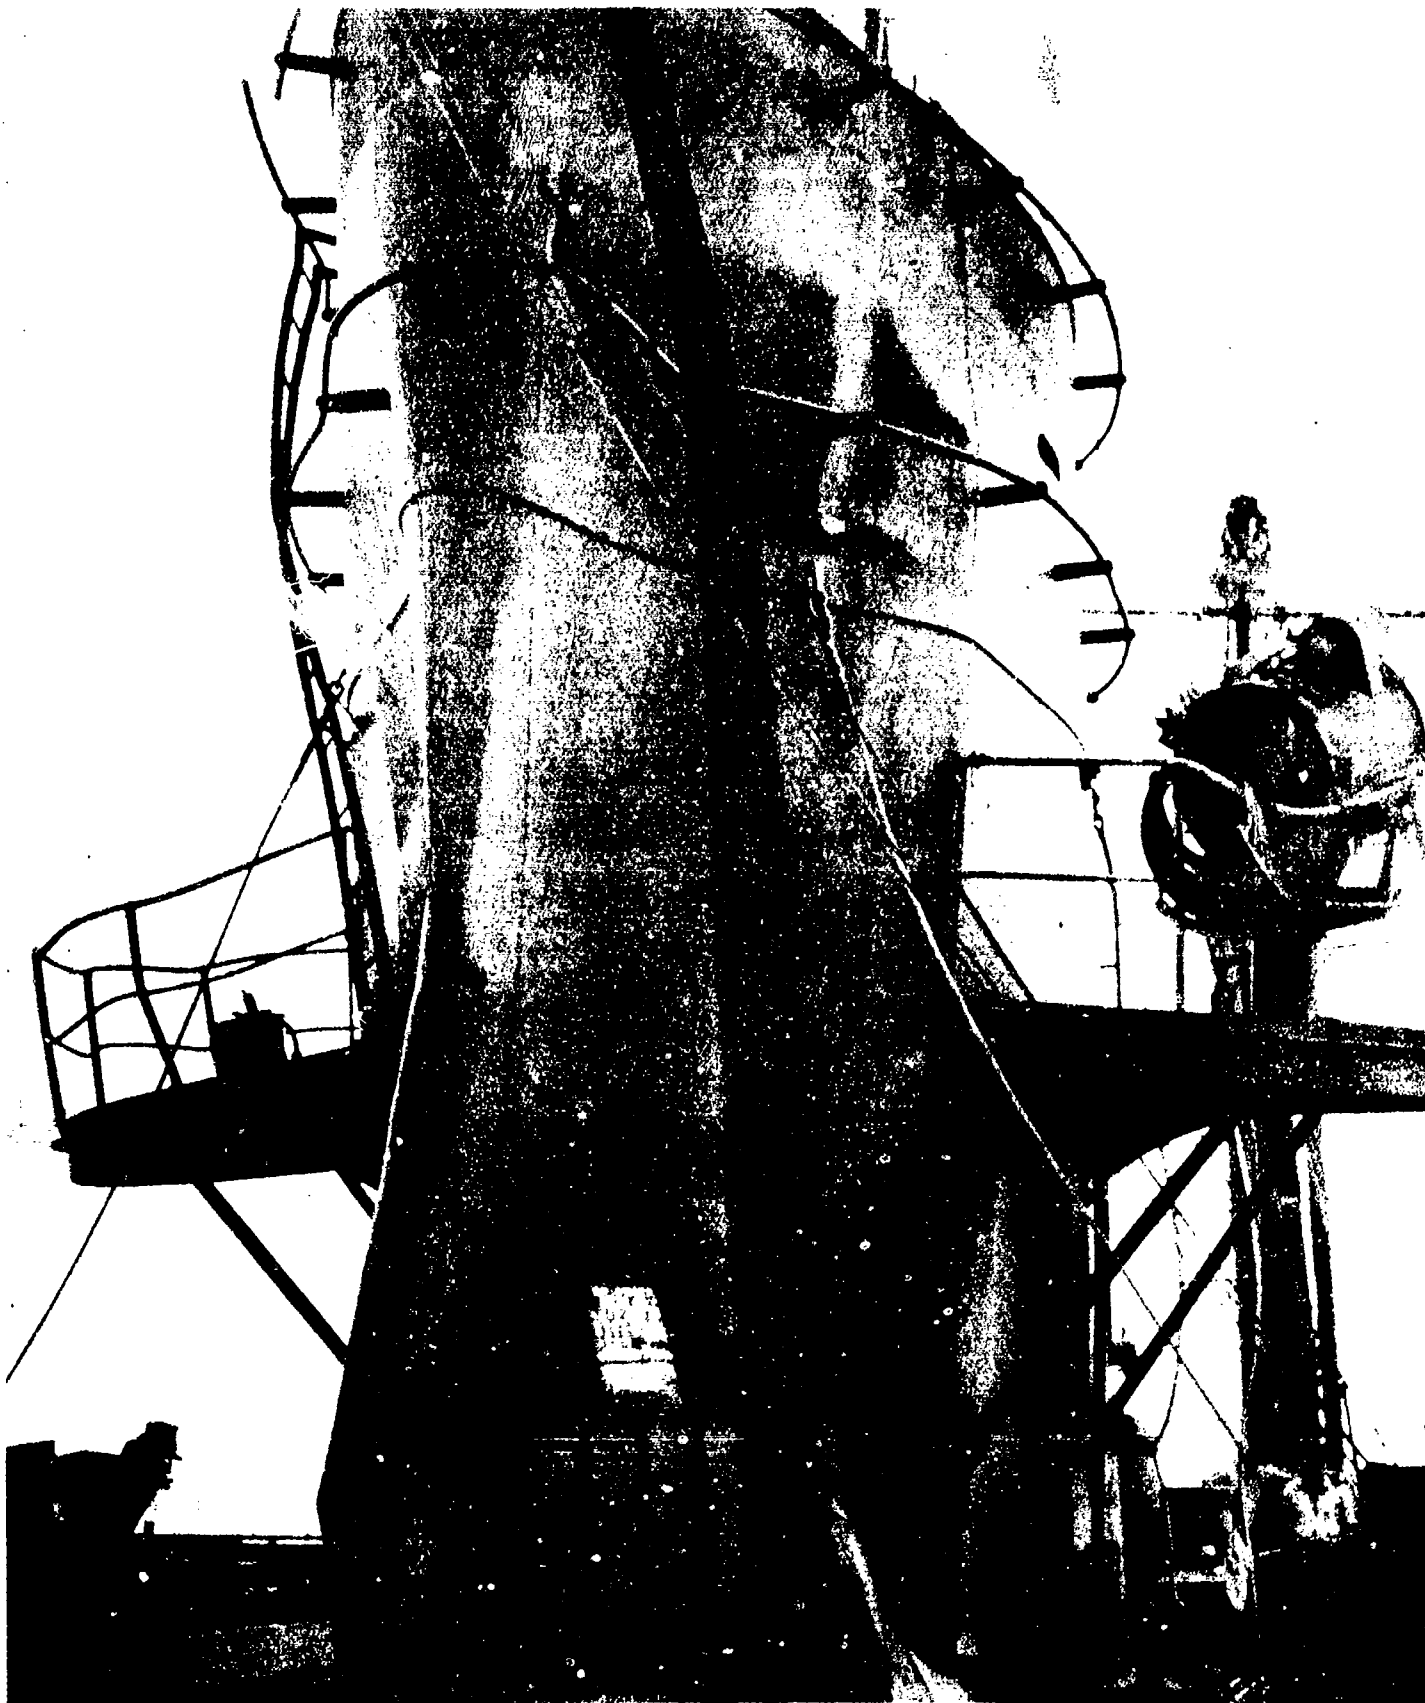
AA-CR-62-1878-6. Looking forward and to port at damage to forward stack. -

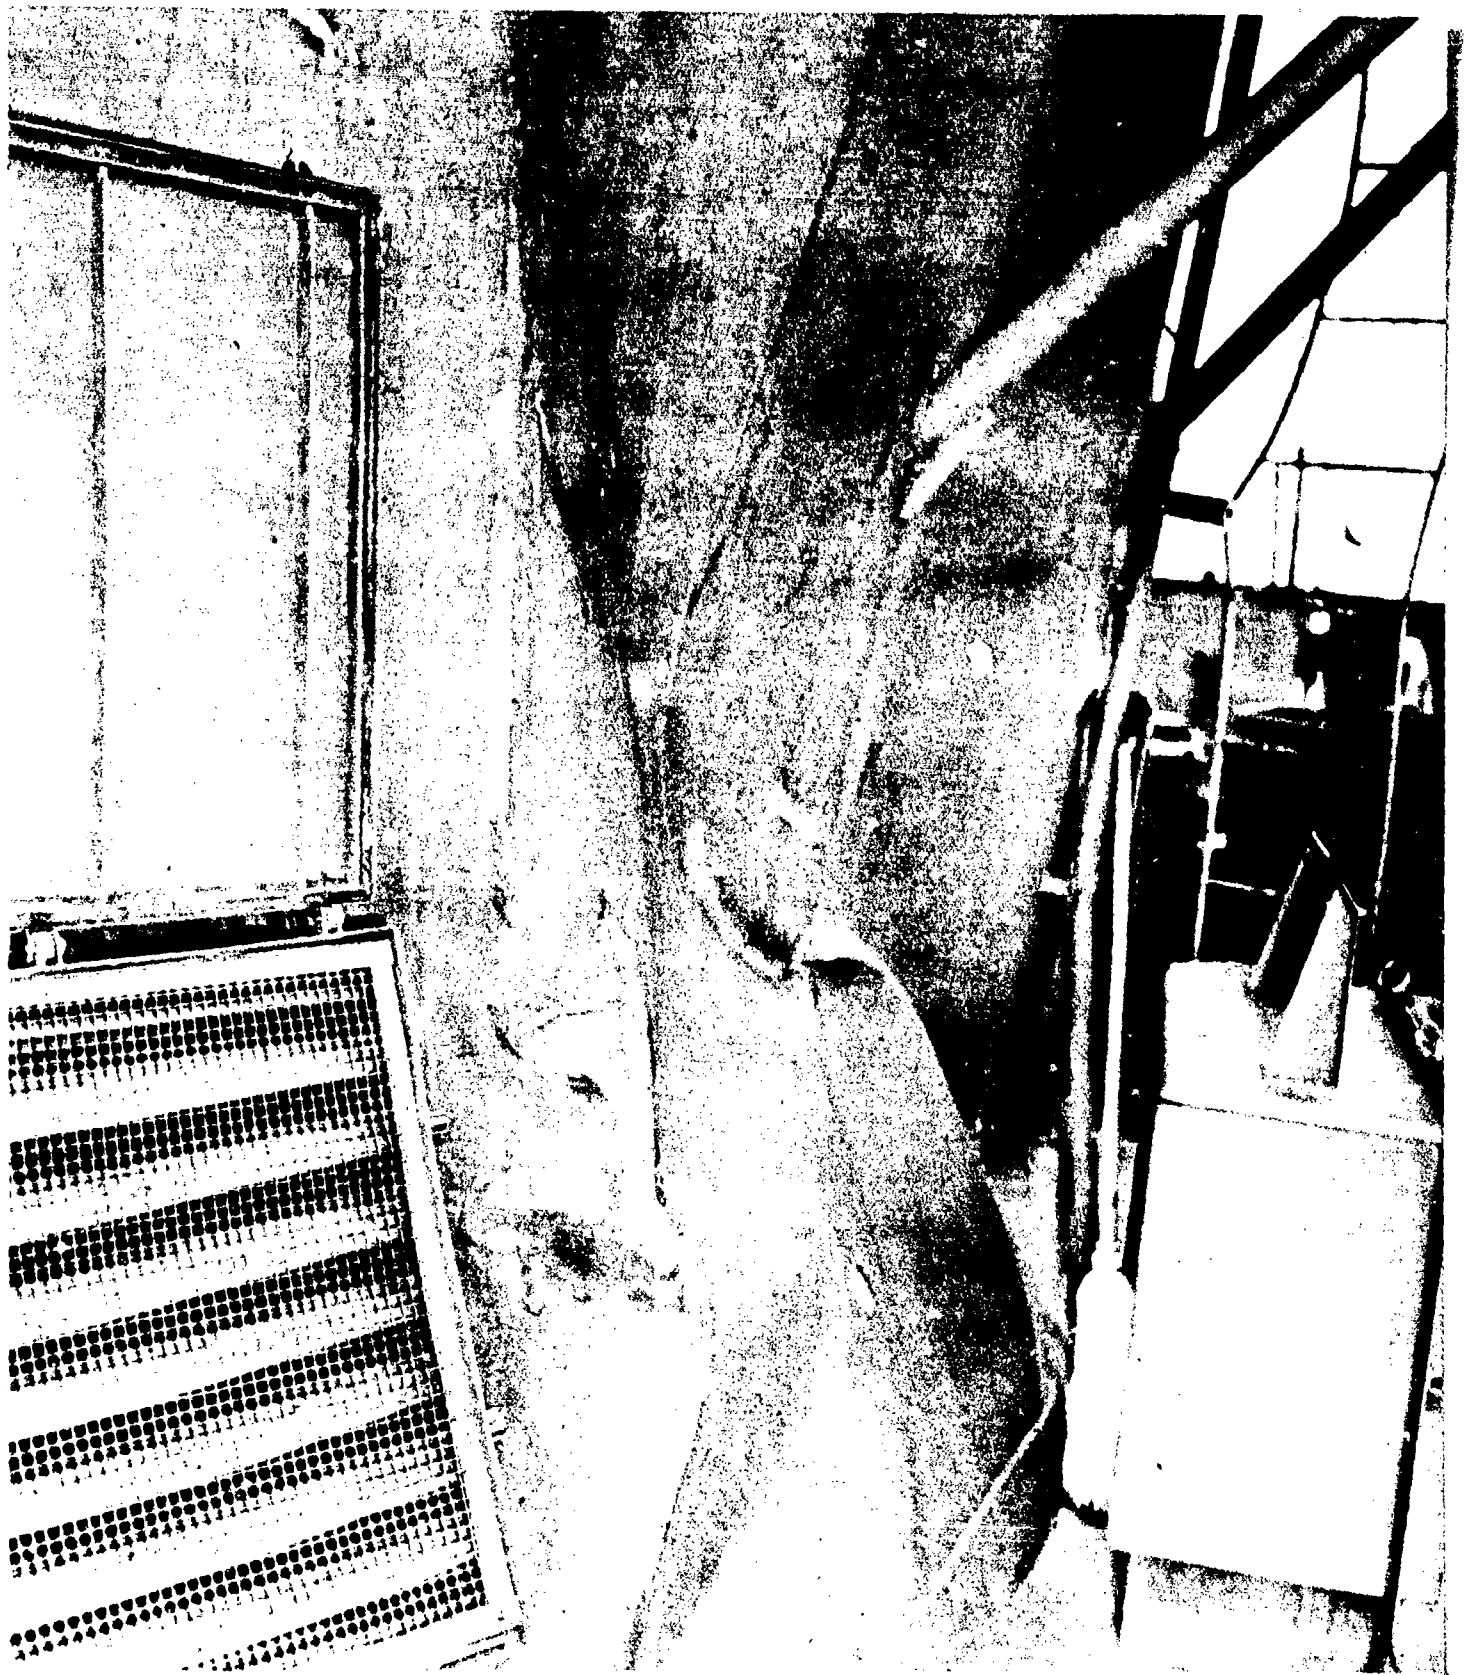
AA-CR-65-1817-7. Looking forward on signal bridge level showing damage to starboard side of forward stack.
